**BorgWarner**

Kysor On/Off Diagnostic Guide

Kysor Rear Air Fan Clutch Diagnostics

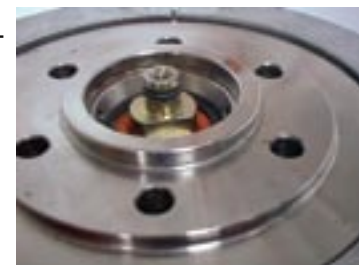
There is no load on the coupler during clutch operation. The coupler simply keeps the clutch piston rod (center shaft) from turning. It couples the piston rod to the shaft of the pulley hub by engaging both the flats of piston rod and the pulley hub shaft. The O-ring on the rear of the piston rod is the air seal between the clutch and pulley hub. (Figure 2)

Figure 2 Clutch with rear O-ring on piston rod

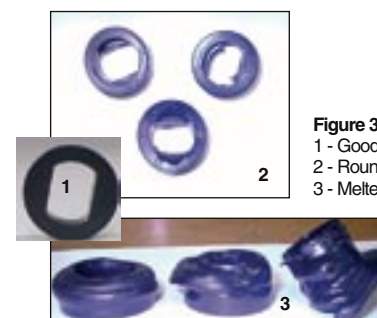
Rounded out damage to the coupler and rear O-ring failure can occur when the clutch piston rod is forced to rotate. (Figure 3-2) This can be caused by a clutch bearing failure or improper clutch servicing. The clutch cylinder cap must be held stationary by hand when removing the front retainer nut.

Figure 3
1 - Good coupler
2 - Rounded out coupler
3 - Melted couplers

If the coupler is rounded out, the clutch ball bearings need to be inspected carefully. The clutch should be replaced if bearings are damaged or worn.
